# Broadway Ave (US 441), Knoxville, Knox County, Tennessee

## Pedestrian Road Safety Assessment Report

September 10-11, 2020

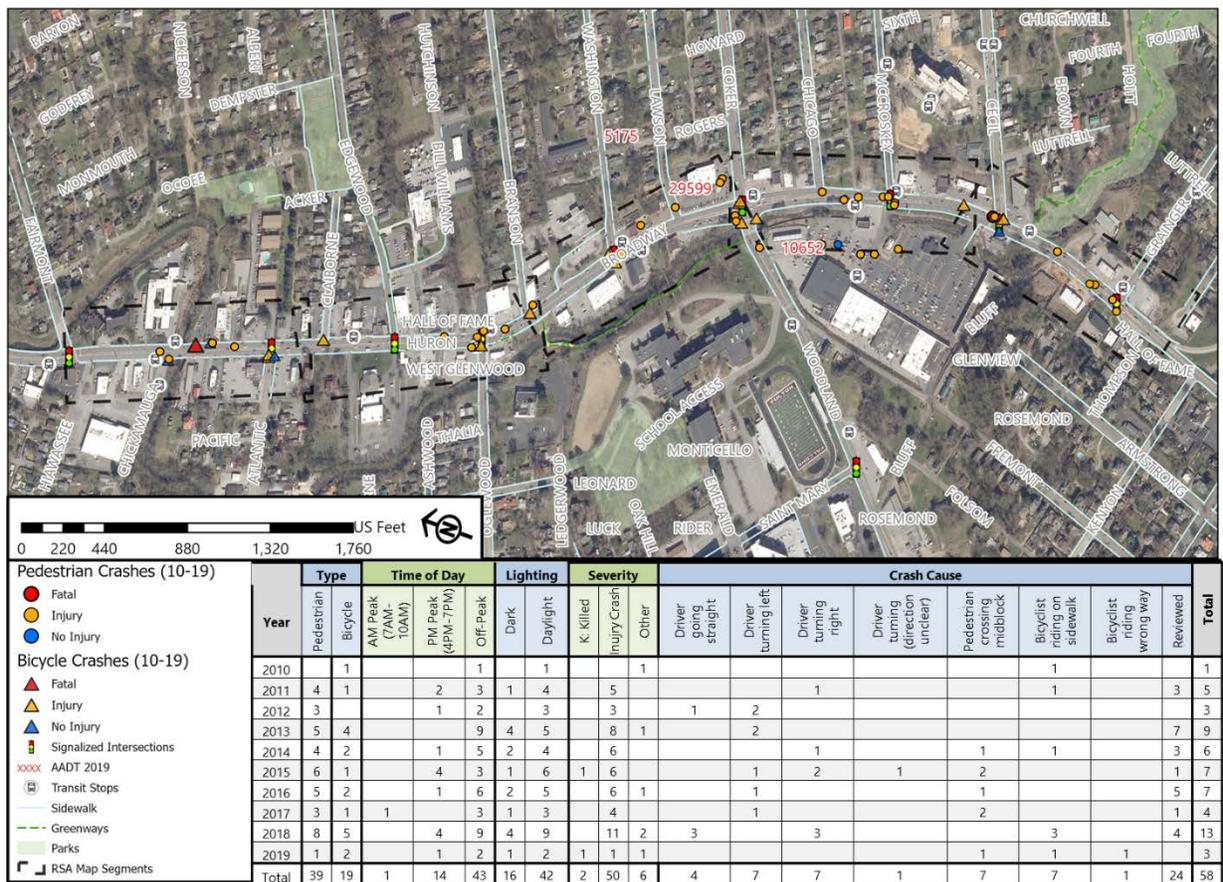
Figure 2 - Reported Pedestrian and Bicycle Crashes, 2010-2019

The majority of the reported pedestrian and bicycle crashes occurred near signalized intersections with marked crosswalks and pedestrian signal heads. Crash clusters (locations with three or more crashes) occurred in all the segments, which may be due to the corridor’s consistent pedestrian-oriented land uses, transit access, and density of signalized intersections, as well as number of areas with elevated risk of conflict. Most crashes occurred outside of peak traffic hours and during daylight conditions (78 percent daytime vs 28 percent dark). However, it is still important to address the nonoperational lighting the nighttime field review revealed in several corridor segments. Non-fatal injury crashes were the most common at 86 percent with 10 percent other (non-injury) crashes, and 3 percent fatal crashes. The

reported crash category was Driver Failure to Yield (33 percent), followed by Lack of Safe Bicycling Facilities (12 percent), and Pedestrian Crossing Outside of Crosswalk (12 percent). Turning Vehicle Crashes (left and right) were for the most common reported crash factor (26 percent), followed by Midblock and Bicyclist-Sidewalk Riding crashes (12 percent each). This indicates issues with pedestrian visibility at intersections, lack of bicycle facilities, and insufficient opportunities to cross the roadway outside of signalized intersections.

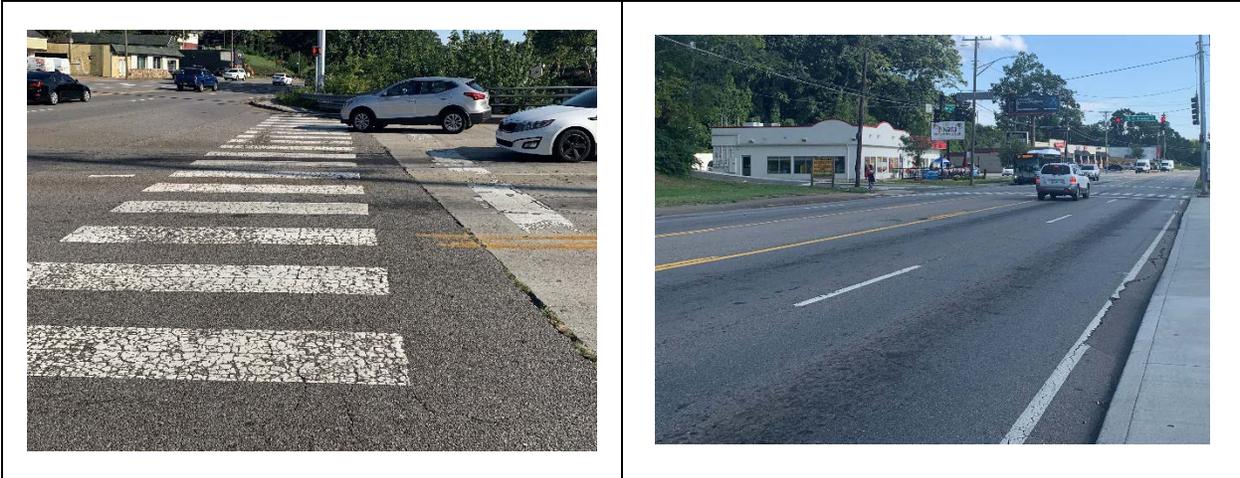
- *Pavement and Marking Quality* – Pavement markings, including crosswalks, appeared faded or worn, reducing their visibility and reflective properties. There are also locations where pavement markings are in need of replacement. Successive repavings have also increased the height of the roadway and created locations where there is limited or no vertical separation from the curb and sidewalk.

*Left Image: A photo, looking south, showing pavement markings at the Coker/Woodland Ave intersection.  
Right Image: A photo of Broadway Ave showing the five-lane cross section with the center two-way left turn lane.*

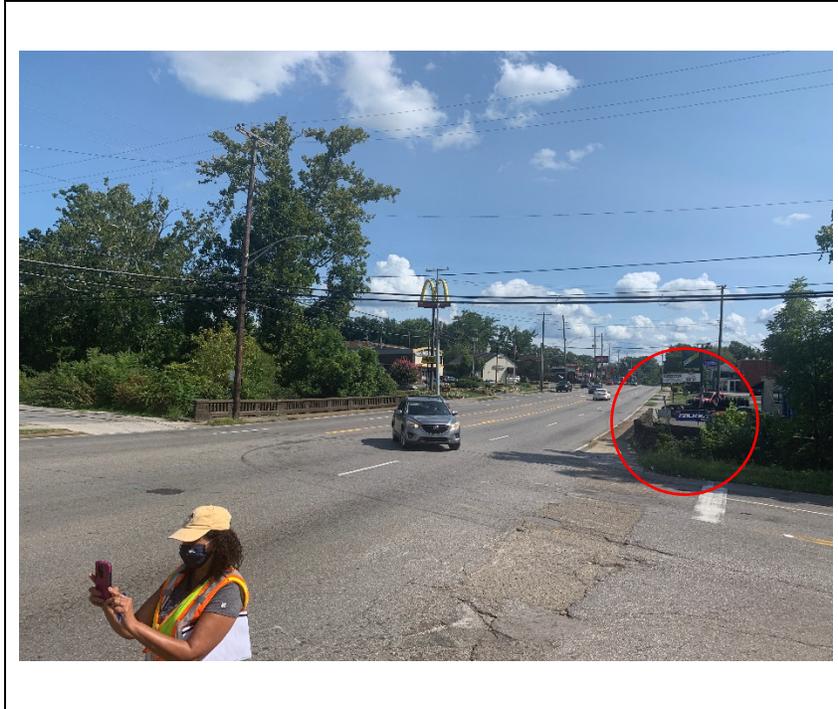
- Traffic Control
  - Chickamauga Ave is stop controlled; the pavement on this street is rough and may need to be resurfaced. Rutting near the curb indicated wide and frequent turns.

- Lighting
  - This segment's lighting was described as low with gaps near Chickamauga Ave. This section of lighting is on a circuit and controlled by one sensor.

*Above Image: A photo, looking south from Chickamauga Ave, showing an uncontrolled intersection and vegetation along the bridge that is reducing pedestrian visibility (red circle). This location was recommended for evaluation for installing a traffic signal.*

- The City will initiate a work order to repair nonoperational lighting near Chickamauga Ave.
- The City and TDOT will treat the vegetation on the northwest corner of First Creek bridge and southwest corner of Atlantic Ave within their respective ROW, and the City will contact the affected property owners and request treatment.
- TDOT and the City will coordinate on refreshing faded crossing markings at Fairmont and Atlantic during scheduled roadway resurfacing projects.

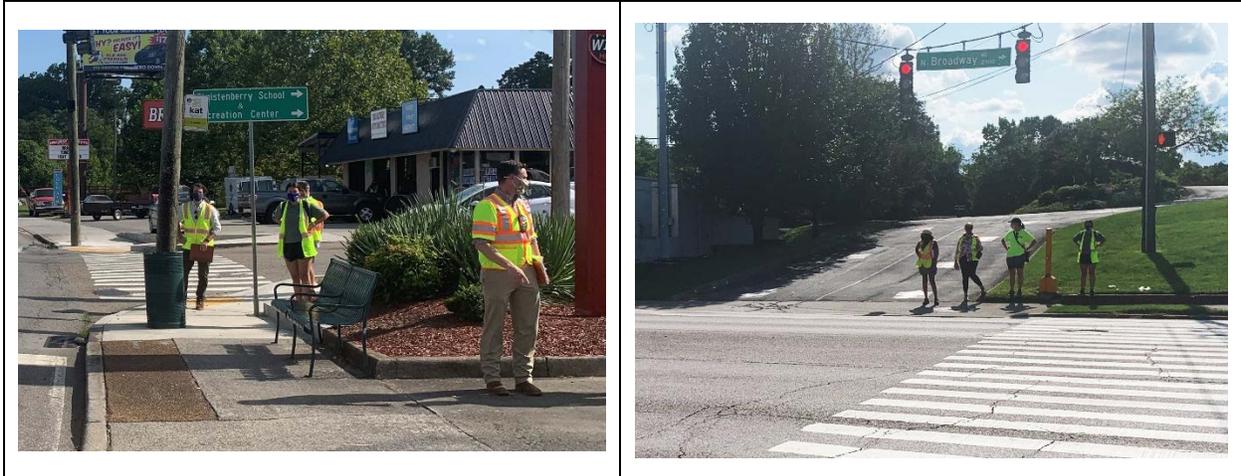
- Land Use
  - The gas station near Oglewood Ave has several access points onto Broadway, including next to the intersection.
- Pedestrian Facilities
  - The marked crosswalk at Edgewood Ave connects to a landscaped buffer.
  - There is no pedestrian signal head at the signalized Oglewood Ave intersection.
  - There are no crosswalks across the north and east legs of the Oglewood Ave and Broadway intersection. There is a utility pole in the northeast corner that reduces the width of the sidewalk and impedes the crossing.
- Transit Facilities
  - The transit stop on the west side of Broadway at Oglewood Ave has a bench, though the stop is on a Shared-Use Path (SUP) and is a conflict point for pedestrians and people waiting to ride KAT.

*Left Image: A photo at the Oglewood Ave intersection, looking south, showing the existing transit stop and bench encroaching on the sidewalk and First Creek greenway connector, and immediately adjacent to a gas station driveway. Right Image: A photo at Edgewood Ave, looking west, showing the marked crosswalk on the northern leg of the intersection connecting to a curb and furnishing strip instead of a curb ramp.*

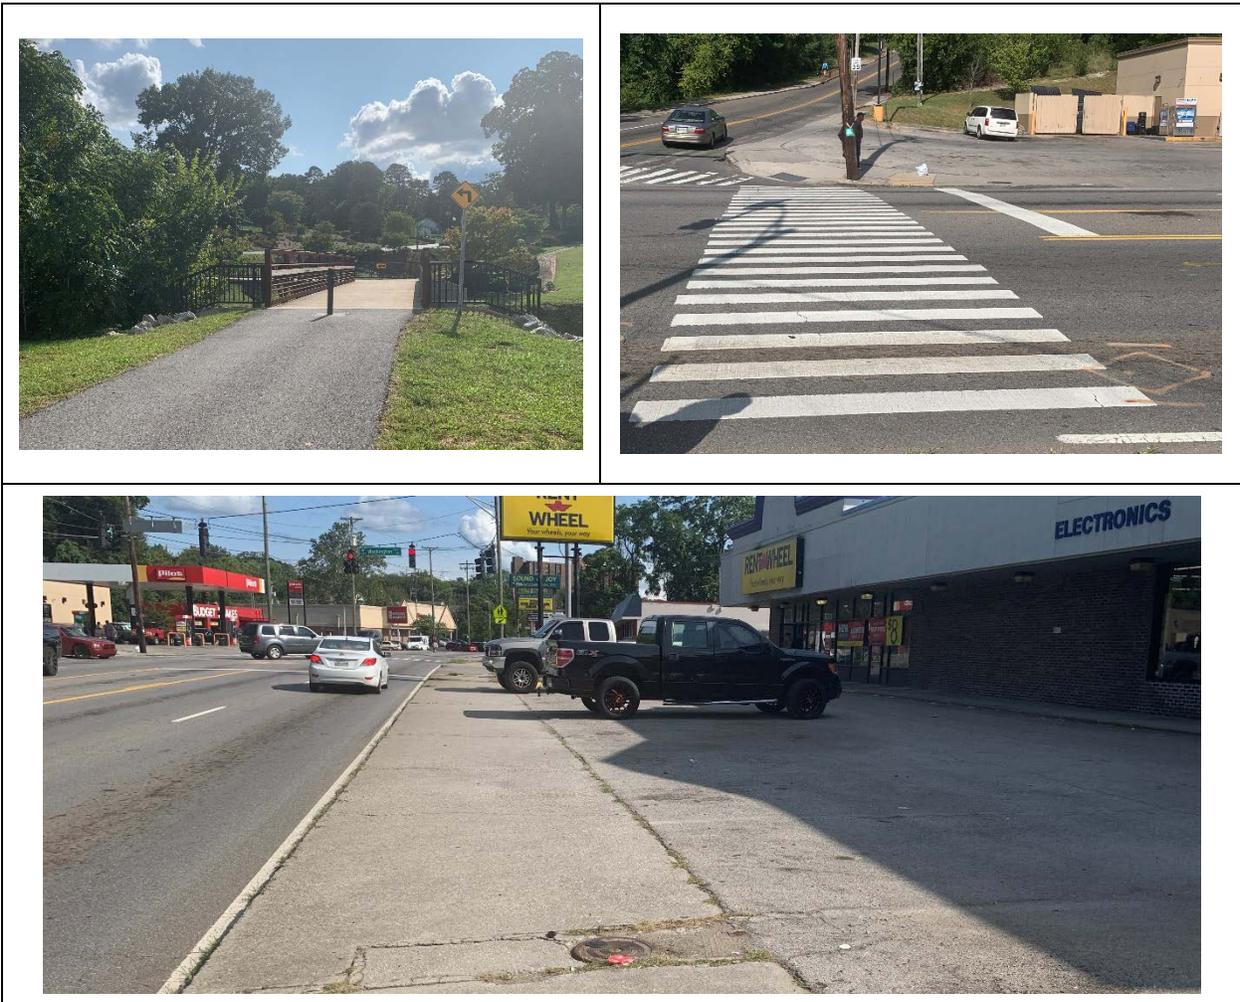
- The Washington Pike intersection has two legs with marked crosswalks, and the markings were faded. There are no pedestrian signal heads. The lack of a furnishing strip may complicate the placement of a pedestrian push button (automatic detection and recall were discussed as options).

- There is open frontage without sidewalks—and delineation from the sidewalk—along the west side of Broadway near Washington Pike.

Left Image: A photo of the First Creek greenway, looking west towards Fulton High School.  
 Right Image: A photo the Washington Pike and Broadway intersection, looking east, showing the signalized intersection with crosswalk that does not have a pedestrian signal head.  
 Bottom Image: A photo north of Woodland Ave, looking north, showing the lack of separation of the sidewalk from commercial parking lots fronting the roadway. Parked vehicles were observed encroaching into the sidewalk.

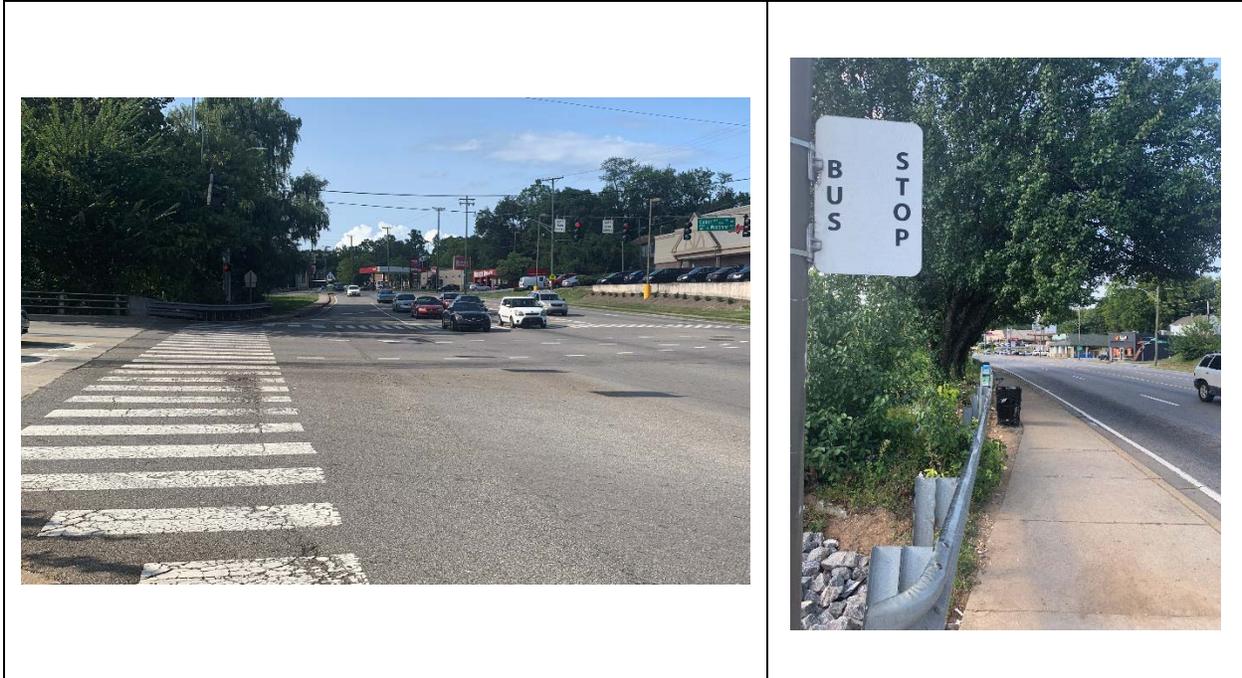
- Transit Facilities
  - The study area's highest ridership KAT stop is the Broadway Shopping Center stop (toward downtown).<sup>4</sup> The stop has a waste bin but no other infrastructure. Riders were observed sitting on a guard rail. There is no separation of the sidewalk from the adjacent commercial property's parking lot.

- Vegetation
  - Vegetation on the southwest corner of Woodland Ave/Coker appeared to obscure pedestrians.
- Lighting
  - The RSA team reported nonoperational light on the southbound approach to the Coker Ave Intersection on the east side (near Walgreens).

*Left Image: A photo of the Woodland Ave/Coker intersection, looking north, showing the wide crossing distances across Broadway. The crossing distance is approximately 100' curb to curb.*

*Right Image: A photo of the KAT Broadway Shopping Center transit stop, looking north, showing the lack of amenities for the corridor's highest use transit stop.*

- City Council District 4 Member Lauren Rider to schedule a meeting with new KAT Director to review the results of the RSA.
- The City will mark a crosswalk across the entrance to the Broadway Shopping Center.
- The City will initiate a work order to repair nonoperational lighting near the Walgreens at the Woodland Ave/Coker and Broadway intersection.
- The City and TDOT will treat the vegetation within their respective ROW at the southwest corner of the Woodland Ave/Coker intersection, and the City will contact the affected property owners and request treatment.

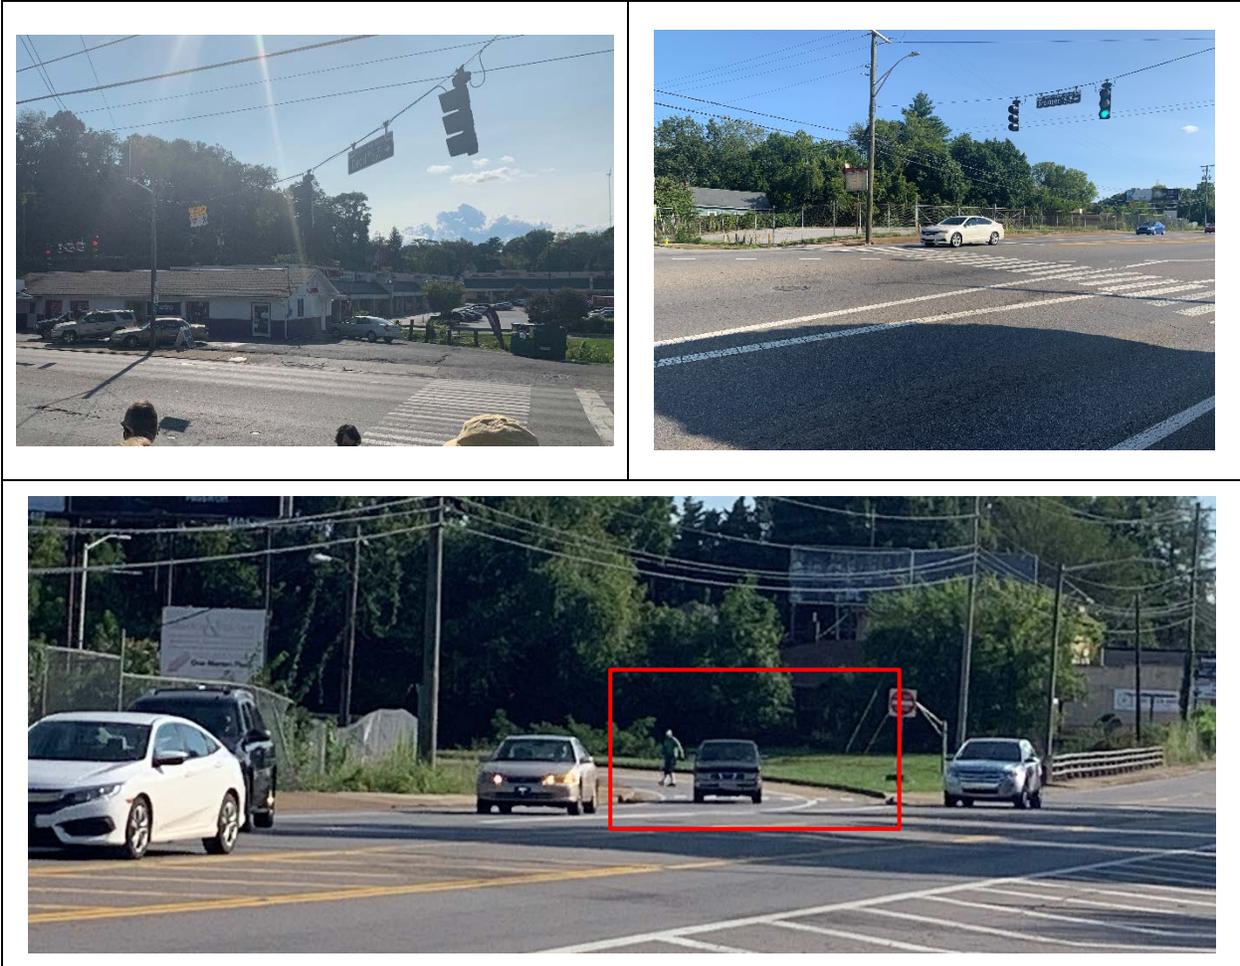
- Northbound vehicles have been observed improperly using the center turn lane to make U-turns on the southbound HoF ramps.
- Pedestrian Facilities
  - Curb ramps at the Cecil Ave intersection are missing truncated domes or detectable warning surfaces. There are crosswalk markings across three legs, and the markings appeared faded.

- The Grainger/HoF intersection is signalized and has one leg of the intersection marked across Broadway, but there is a continuous free-flow southbound lane. There are no pedestrian signal heads.

- There is a faded marked crosswalk with pedestrian warning signage across the northbound off-ramp to Broadway.

*Left Image: A photo at the Cecil Ave intersection, looking west, showing the lack of a pedestrian signal head at this high-pedestrian-crash intersection.*

*Right Image: A photo of the Grainger Ave intersection, looking south, showing the crosswalk spanning a free-flow southbound on-ramp.*
