**Part  
B**

Opportunities, Constraints, &  
Preliminary Design

# Map 1

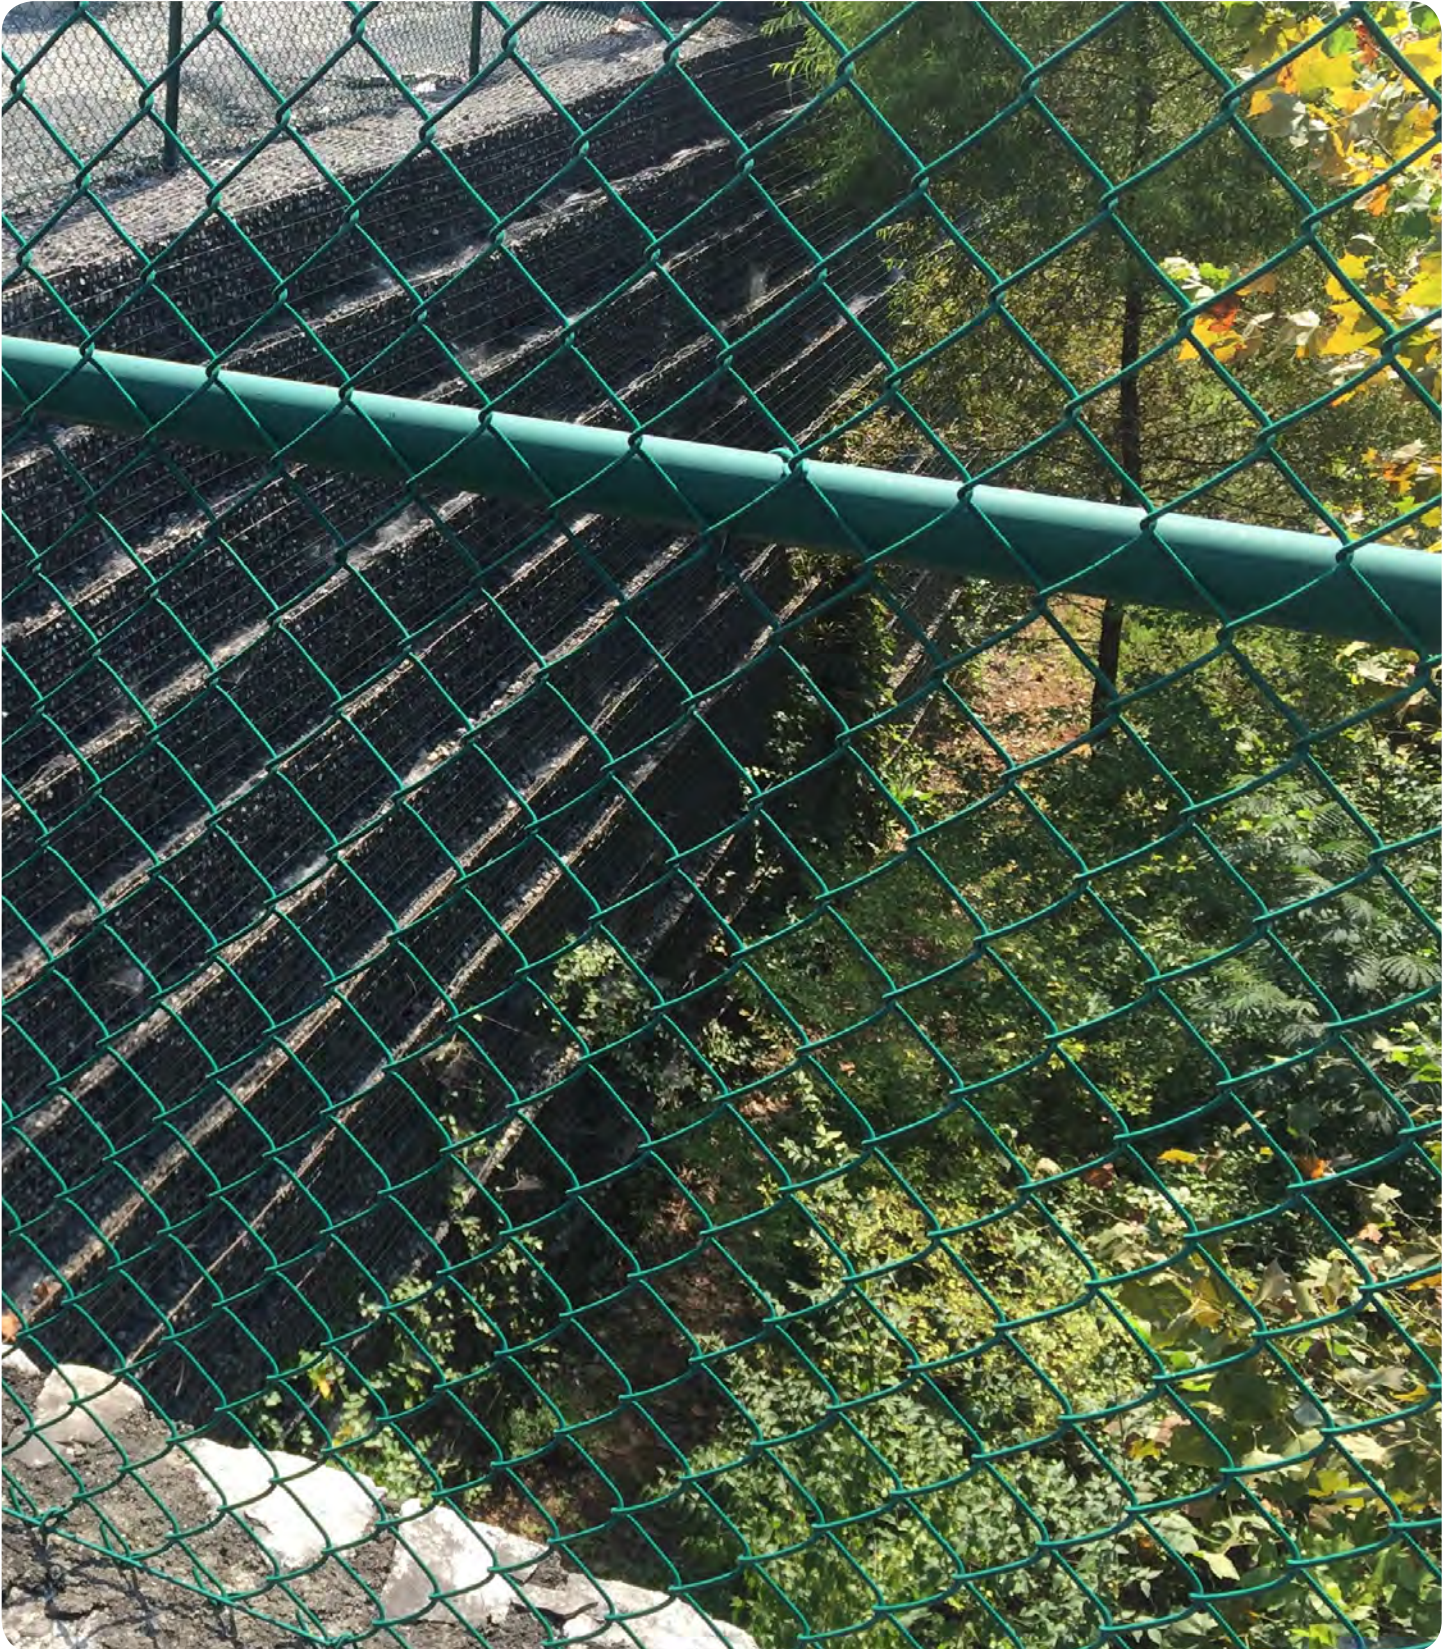
## Opportunities and Constraints Notes:

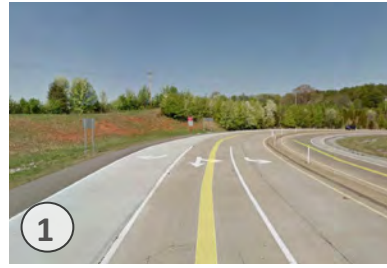
(1) The ridge in distance is in TDOT ROW and may be suitable for a greenway.

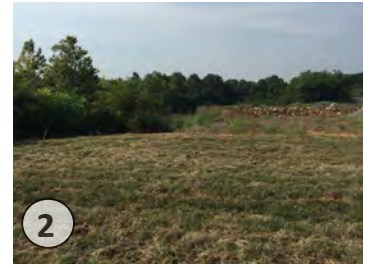
(2) A large tract of undeveloped land has gently sloping floodplain (Turkey Creek shown in background).

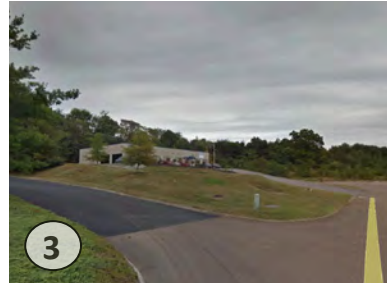
(3) Ridge in the background may be suitable for a greenway.

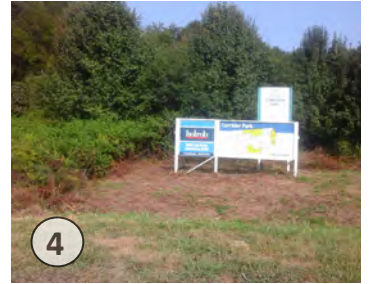
(4) Corridor Park Boulevard is flat and largely undeveloped on its northern side.

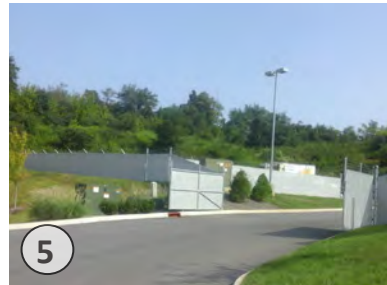
(5) Deerborn Lane has steeper slopes to the north, creating a barrier to a greenway.

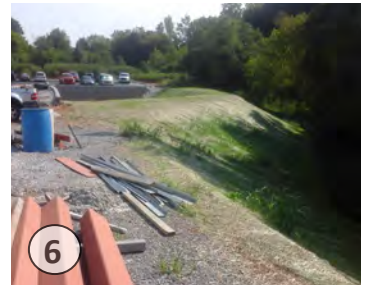
(6) Recent grading and construction in this area constrain the potential for a greenway

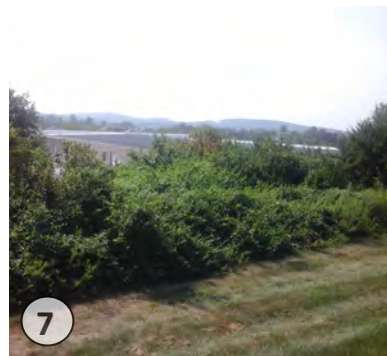
(7) View from a bench that has the potential for a greenway.

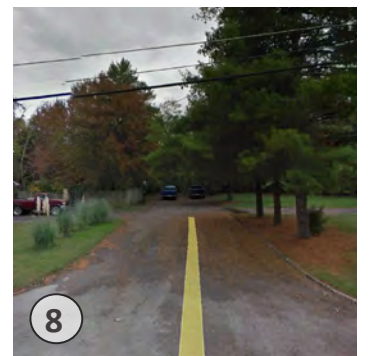
(8) Poco Road is a small dead-end side street that could serve as access to a potential ridge-line greenway.

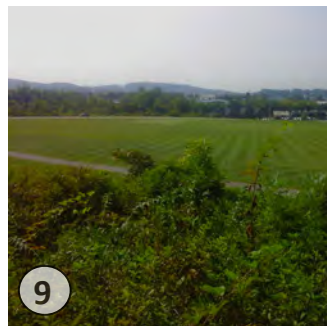
(9) View of existing US Cellular Soccer Complex Greenway.

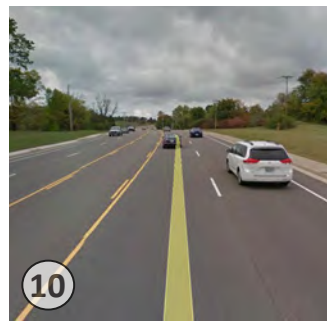
(10) View of Lovell Road at potential crossing area.

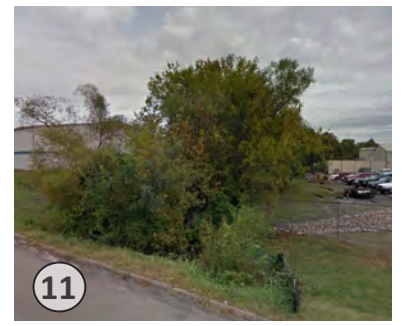
(11) Turkey Creek floodplain in this area is completely built out with fences, grading, and restricted access areas creating multiple barriers to greenway development.

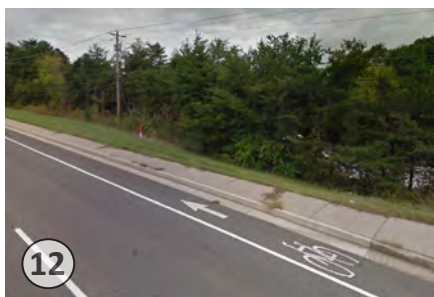
(12) View of existing Lovell Road bicycle lane and sidewalk.

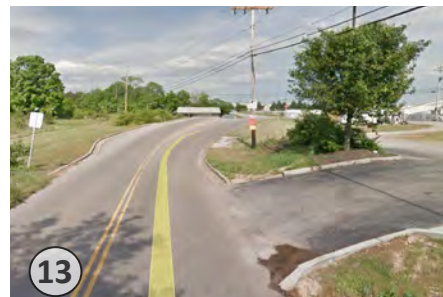
(13) View from Gilbert Drive of potential crossing area, which is 200 feet from Lovell Road.
